## **2010 Annual Inspection Report**

### **Jonathan Davis Wetland Protection**

State Project Number BA-20  
Priority Project List 2

December 15, 2010  
Jefferson Parish

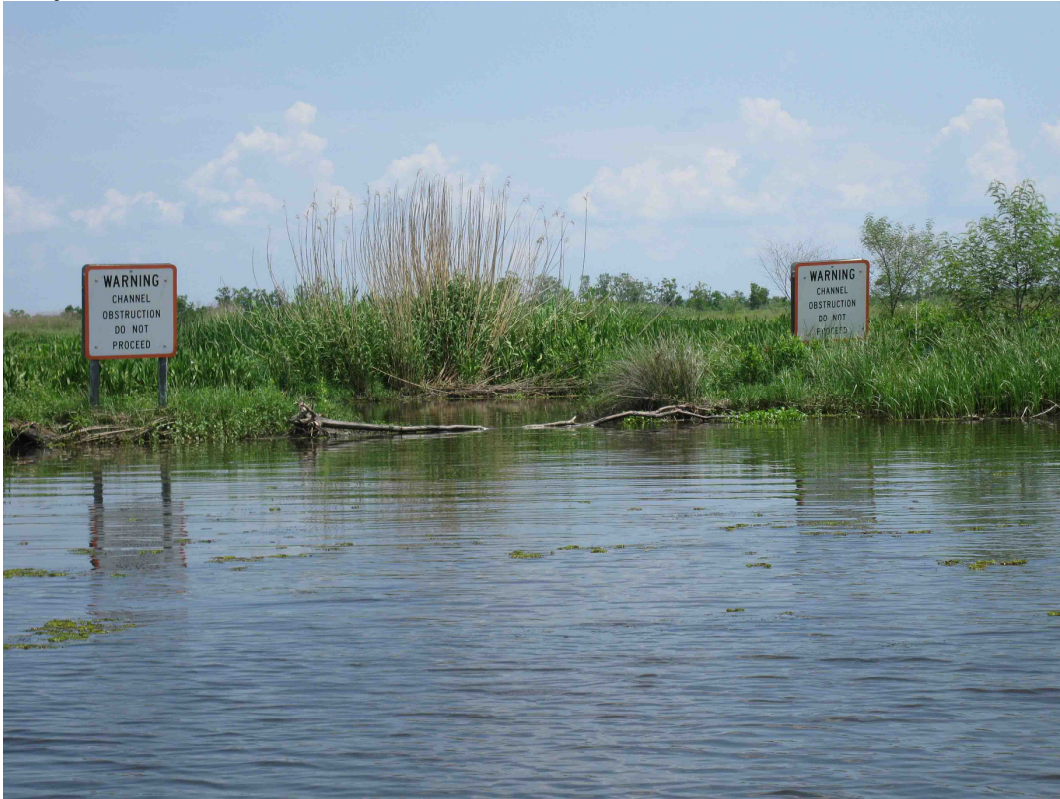
**Photo #1 – Structure #14 (Note Gap)**

Upon a visual inspection, we noticed a large breach on the west side of the structure and in the center of the structure (Photo #1). Due to poor soil conditions, this structure has experienced significant settlement problems since the time it was constructed. Several attempts were made during construction to stabilize the structure by placing several lifts of rock, but the structure continued to settle. It was discussed that the breach leading into a small bayou was not a problem at this time, but the construction contract for Construction Unit 4 will include refurbishment of the structure to elevation 3.5 NAVD88.

Construction Unit 4 will provide maintenance for Structures 14, 15, and 17. There is no need for any other maintenance activity at this time.

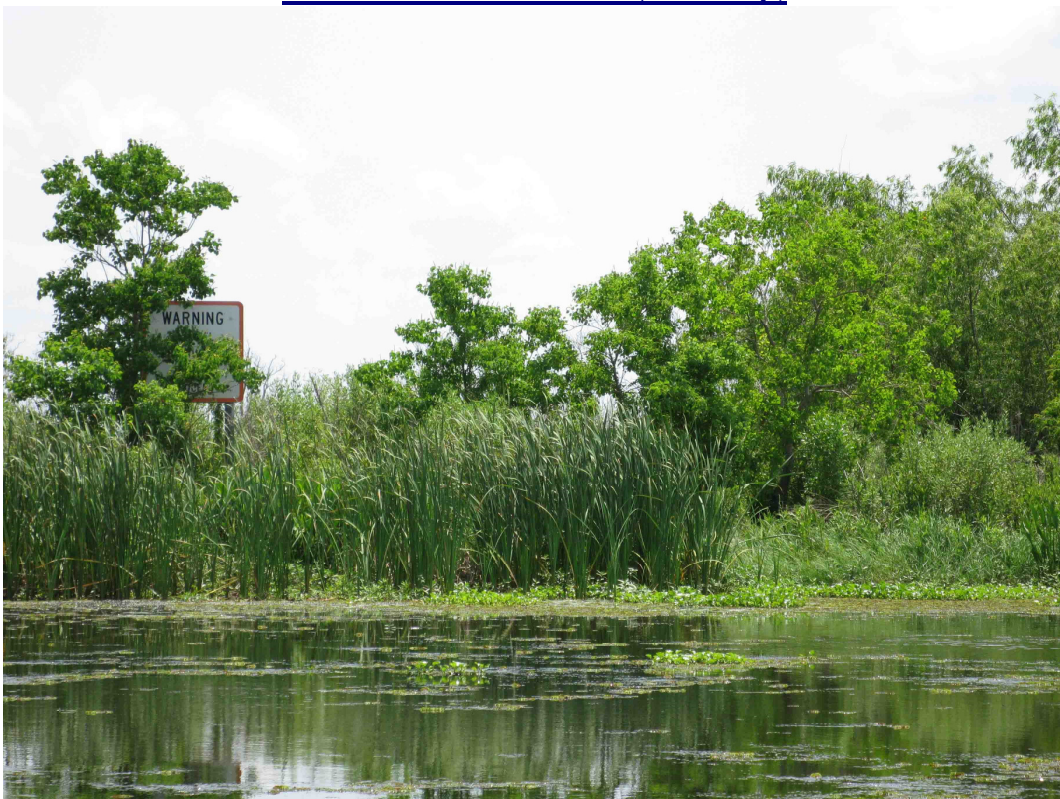
**Photo #2 – Structure #16 (Note Vegetation)**

Structure 16 was difficult to inspect due to the amount of vegetation growing on the structure. (Photo #2) Assume no change and plan for future maintenance work for this structure.

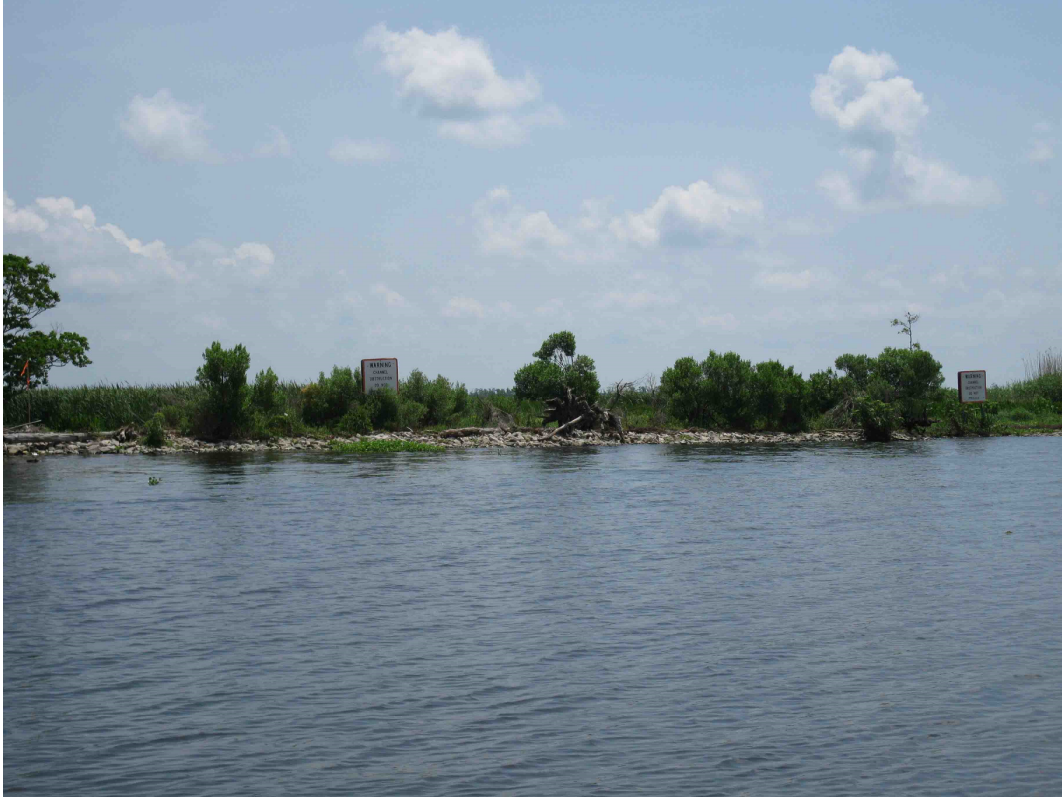
**Photo #3 – Structure #17 (Low Spot on Right)**

During the inspection, we observed significant settlement near the warning sign on the south side of the structure and just east of the warning sign on the north side of the structure. (Photo #3) This structure will be refurbished to an elevation of 3.5 NAVD88 during the construction contract for Construction Unit 4.

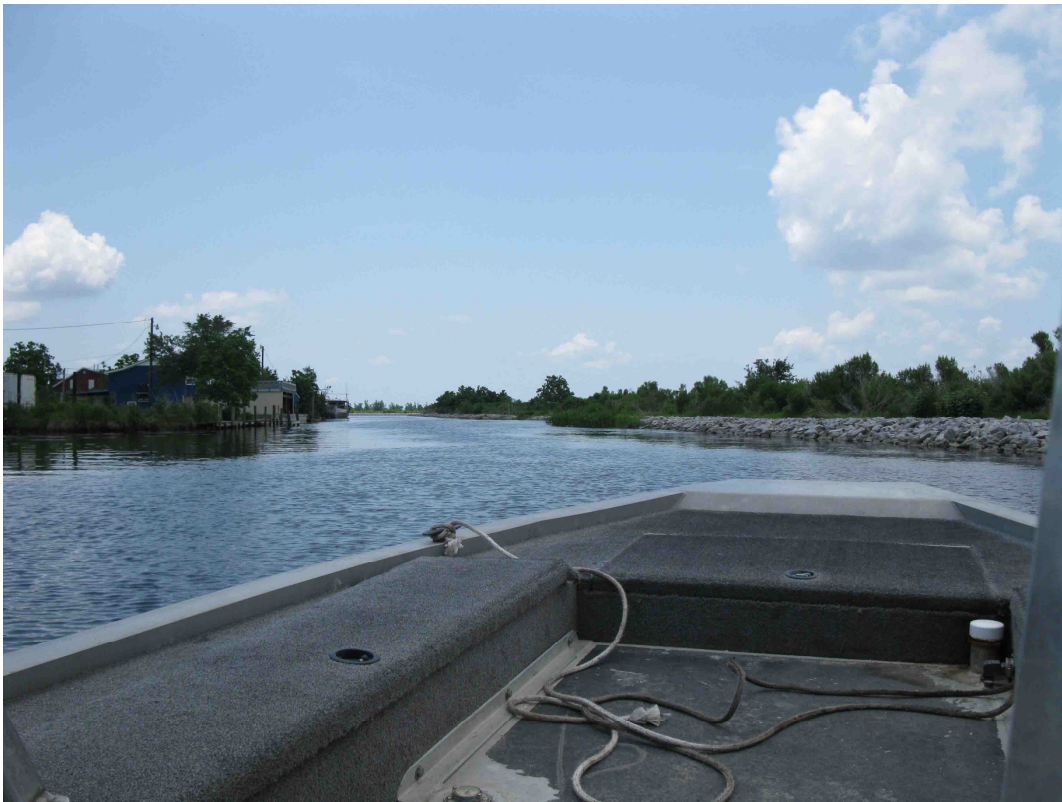
**Photo #4 – Structure #22A**

The structure looked to be in good condition. There were few signs of settlement along the bank stabilization. (Photo #4) OCPR and NRCS agree that maintenance of this structure is not needed at this time.
